WATERSHED SURVEY REPORT

GREAT POND, BELGRADE LAKES

GREAT POND WATERSHED SURVEY REPORT

Ecological Instincts
P.O. Box 682
Manchester, ME 04351
www.ecoinstincts.com

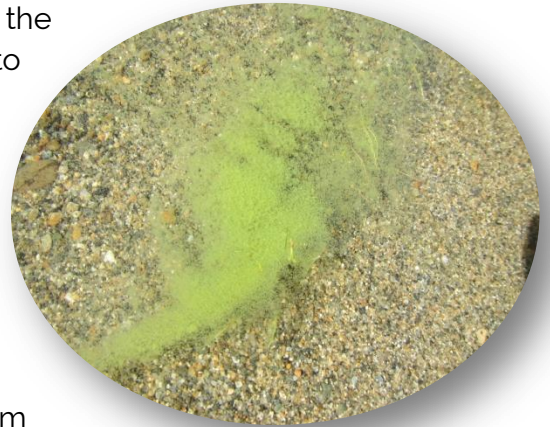
Algae floating in the shallows of upstream North Pond.

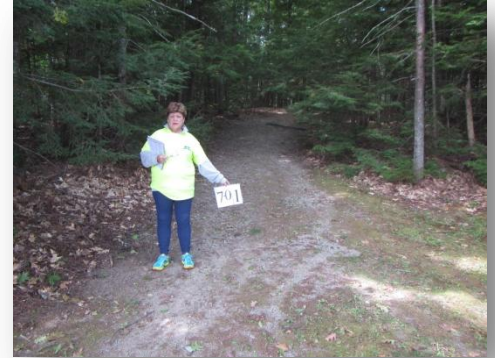
Driveway erosion can result in significant delivery of nutrients and sediments to Great Pond.

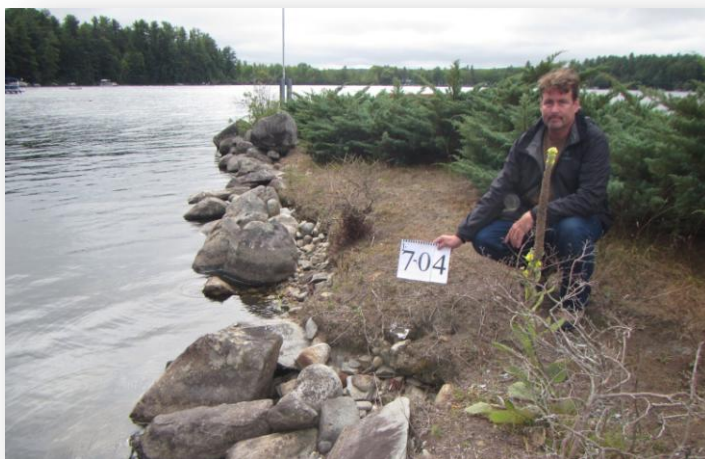
Examples of residential NPS sites: a) Shoreline erosion caused by removal of native vegetation on a residential site in Sector 7 (above); and b) A compacted and eroding path to the lake in Sector 11 (right).

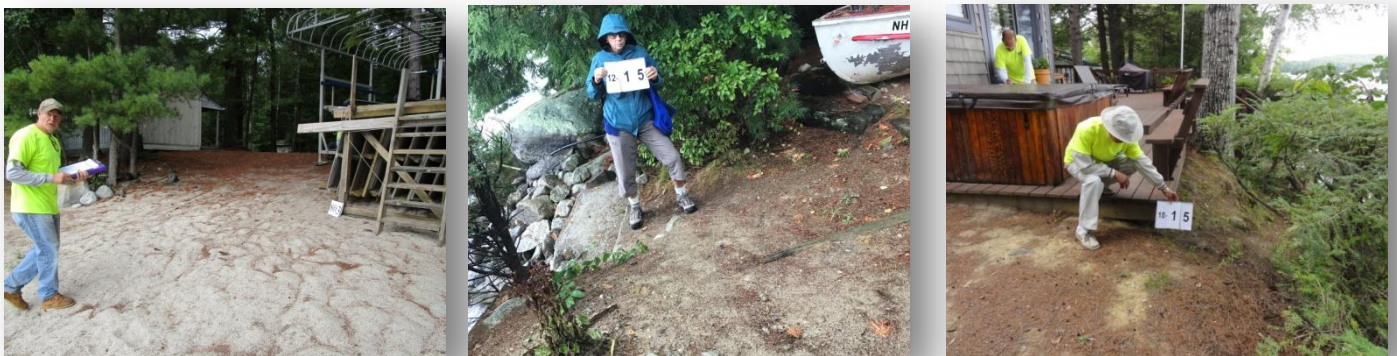
Examples of residential sites ranked high (left), medium (middle), and low (right) impact.

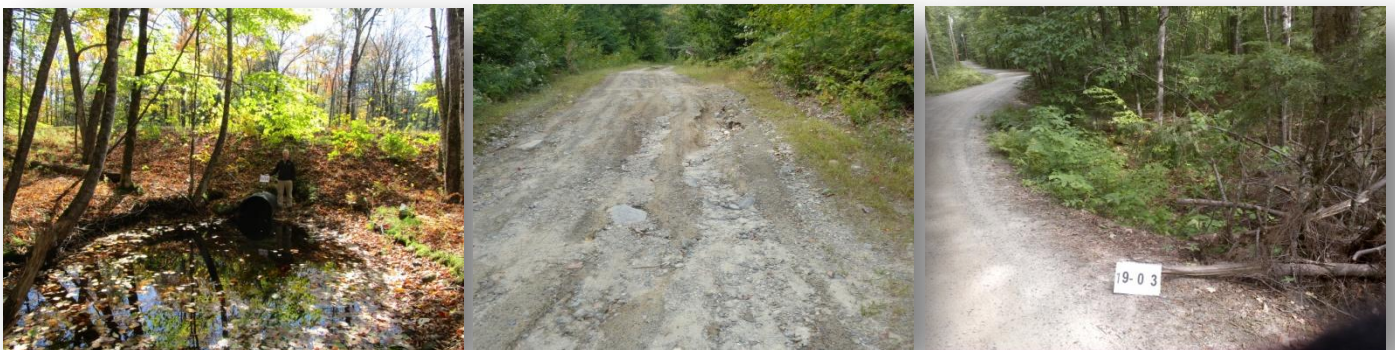
Examples of road sites ranked high (left), medium (middle), and low (right) impact.

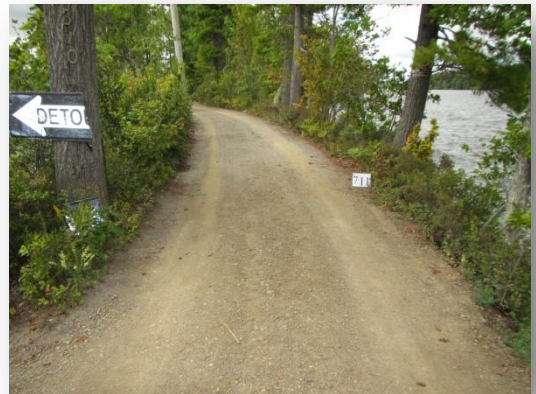
Example of a high-impact private-road site in Sector 17.

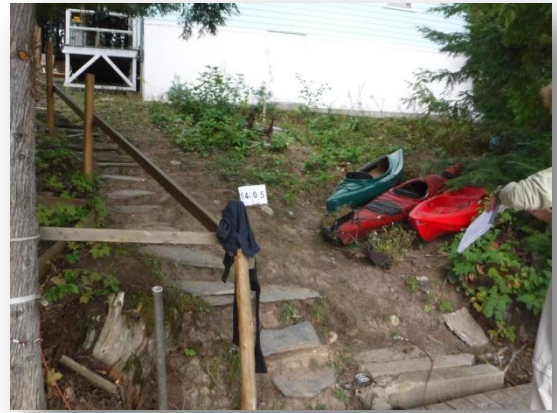
An old walkway requires retrofitting to prevent soil erosion from getting to the lake on Togue Road in Sector 14.

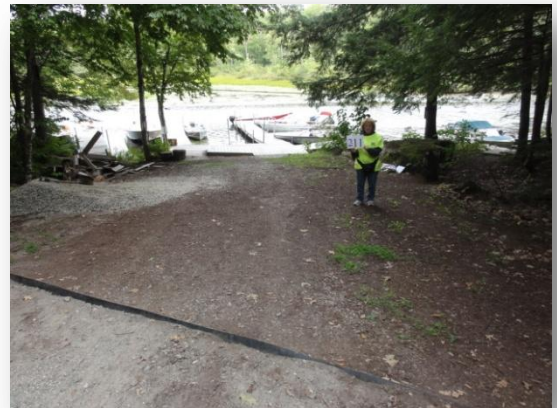
A rubber-razor needs repair to hold back soil at this commercial camp in Sector 2.

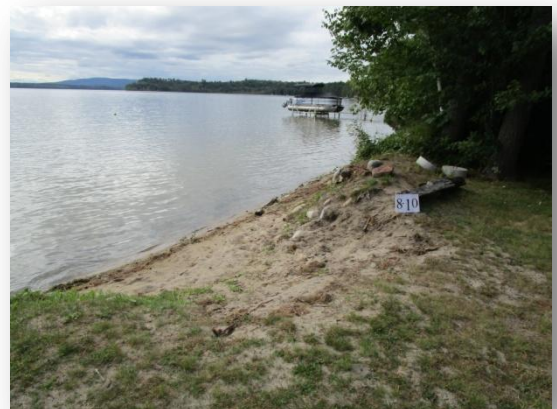
Example of a low-impact beach-access site in Sector 8.

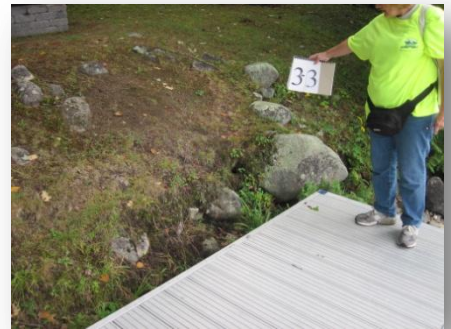
Shoreline erosion in Sector 3 due to lack of vegetation. Roots from woody vegetation help stabilize shorelines.

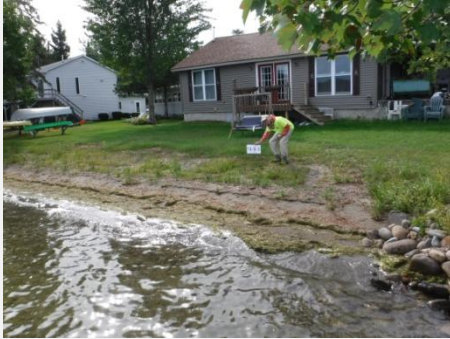
Sector 13: Site 3

Problem: BARE SOIL, SURFACE EROSION, INADEQUATE SHORELINE VEGETATION

Solution: Control runoff from impervious surfaces. Use erosion control mulch in areas with exposed soil, and plant vegetation along the shoreline to stabilize banks and filter runoff. Consider planting vegetation before using rip rap, or use a combination of both, minimize lawn area, and add dripline trenches to roof driplines.
