WATERSHED SURVEY REPORT

GREAT POND, BELGRADE LAKES

GREAT POND WATERSHED SURVEY REPORT

Ecological Instincts
P.O. Box 682
Manchester, ME 04351
www.ecoinstincts.com

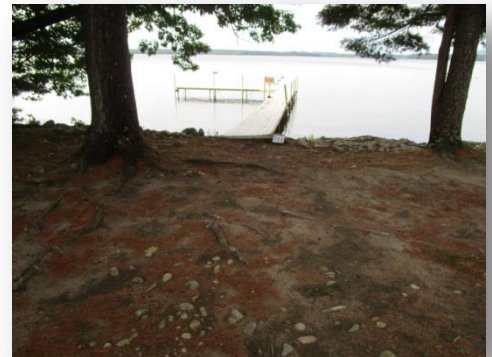
Lack of shoreline vegetation and bare soil near the shoreline creates erosion problems that allow nutrients and sediments to get to the lake.

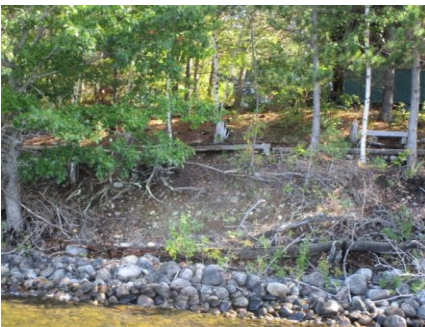
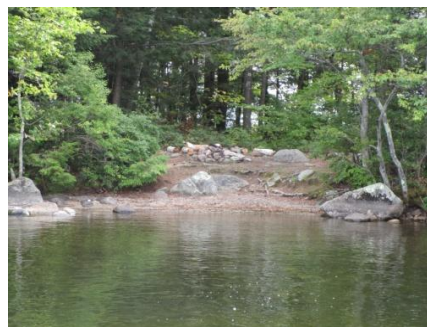
Steep banks on the shores of Pine Island have resulted in years of soil erosion (left); access by boaters to undeveloped islands can result in shoreline erosion, as seen on Oak Island (right).

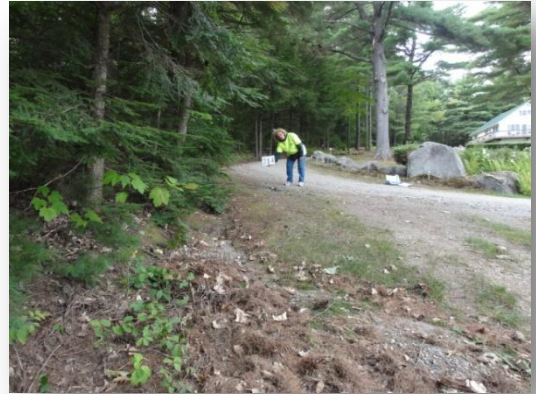
Example of a high-impact driveway site on Nickerson Lane in Sector 2.

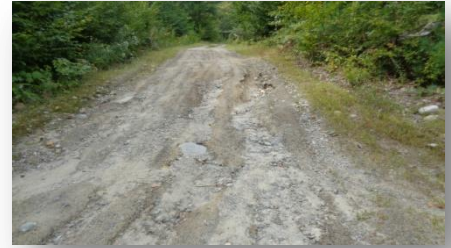
An eroding private road site on Homestead Rd. in Sector 1. New surface material, runoff diversifiers and ditches are needed.

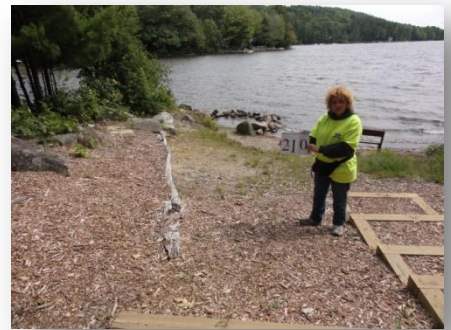
The Rome town beach in Sector 2.

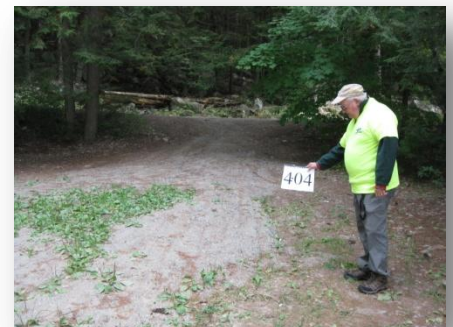
Driveway runoff in Sector 4 on Hathaway Lane.

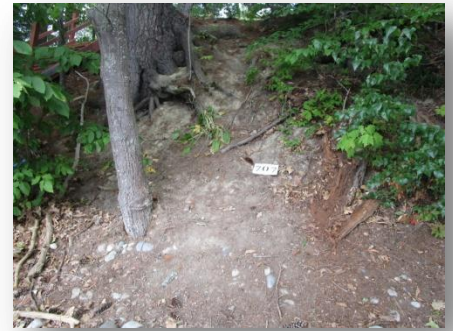
Steep, eroding banks along the shoreline, seen here in Sector 7, can result in significant deposits of soil and nutrients in the lake.

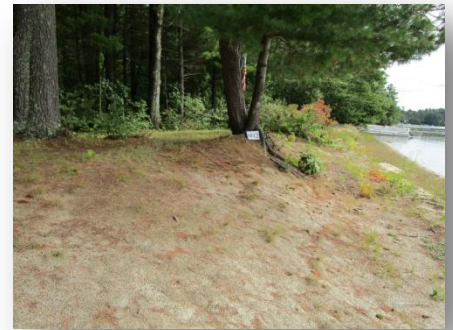
The addition of a vegetated buffer at this residential property in Sector 8 would prevent soil from washing into the lake.

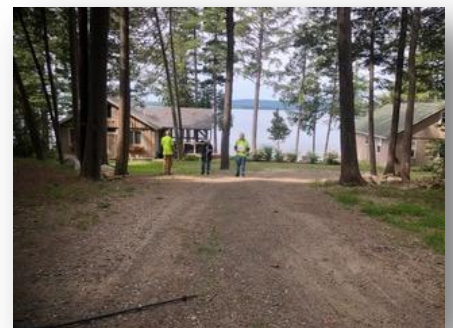
A high-impact driveway site in Sector 9 leads directly to the lake.

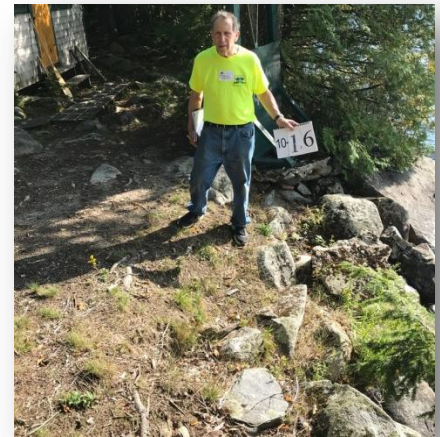
Maintaining and adding vegetation along the shoreline in Sector 10 will reduce runoff to the lake,

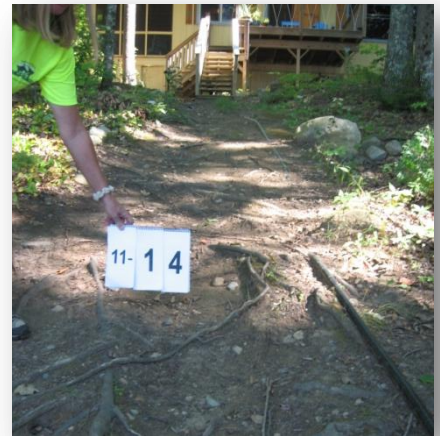
Trails & paths become compacted and deliver sediment directly to the lake.

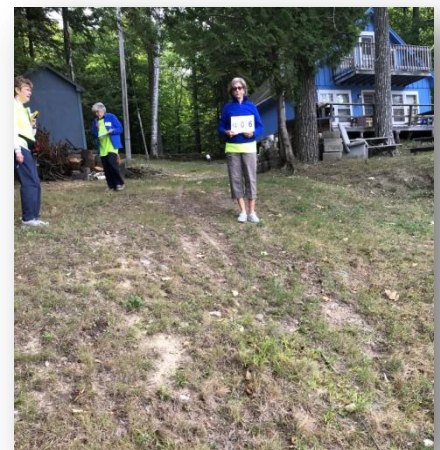
Roof runoff and lack of shoreline vegetation at this Sector 12 property has resulted in ongoing soil erosion.

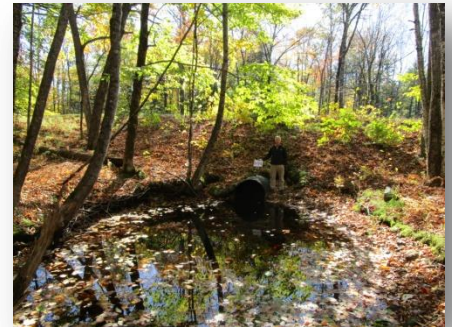
A large scour pool at the outlet of the Castle Island culvert in Sector 16.

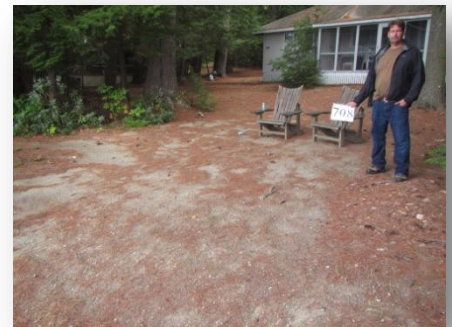
Bare soil on a residential property in Sector 17 has resulted in sheet erosion.

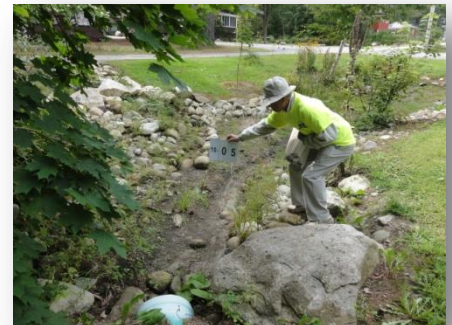
A detention basin is needed to collect and settle out sediment washing off Hulin Rd. in Sector 18.

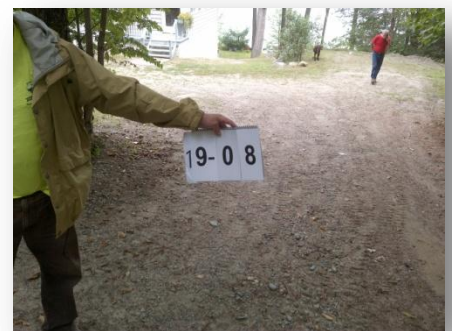
Large areas of bare soil near the water's edge and lack of adequate buffer in Sector 19.

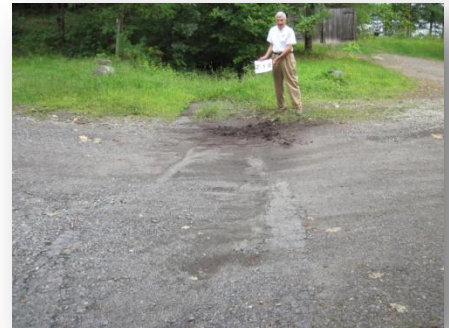
Improvements are needed at a commercial parking lot in Sector 20 to prevent sediment from getting into the lake.

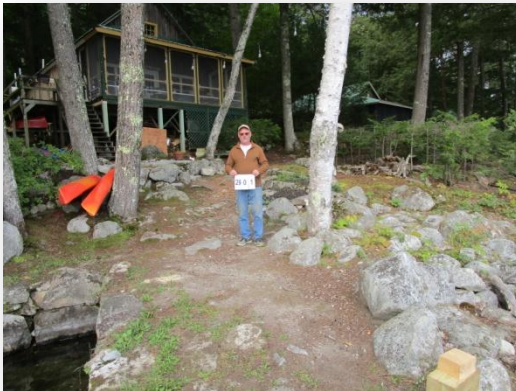
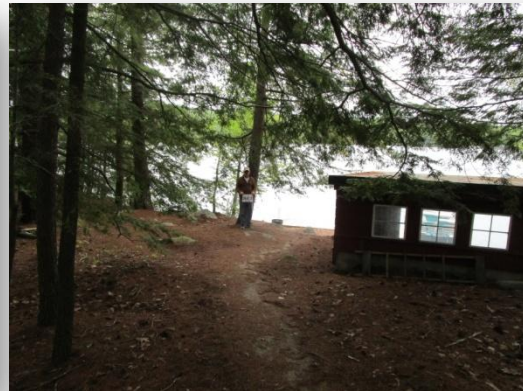
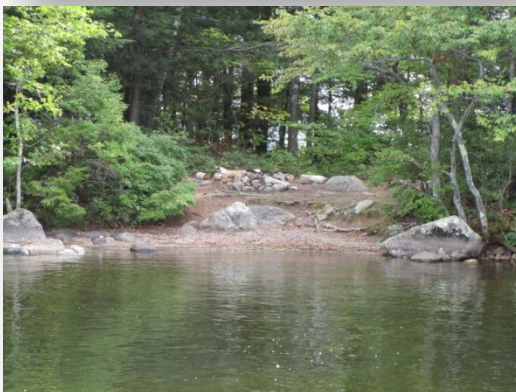
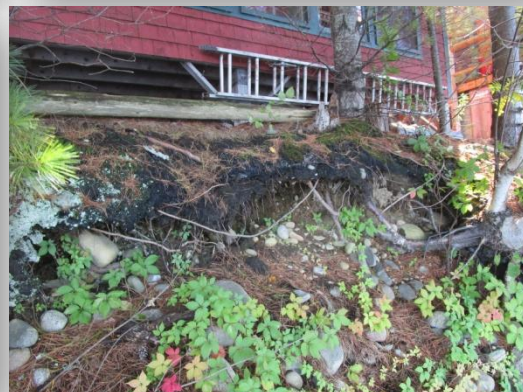
NPS sites were documented on Hoyt's, Indian, Pine Island and Oak Island. Problems were mostly associated with beach/boat access or trails/paths. Pine Island had multiple sites including a large stretch of eroding shoreline, and erosion associated with trails/paths, tent platforms, beach access, etc. Future planning for Great Pond should include the potential effects of septic systems and other types of waste systems (e.g. cesspools, outhouses, etc.) on the water quality of Great Pond.

NPS sites were documented on Hoyt's Island (top left), Indian Island (top right), Oak Island (bottom left), and Pine Island (bottom right).

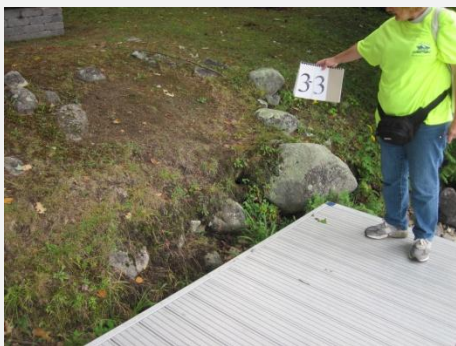
Sector 3: Site 3

Problem: UNSTABLE BEACH & BOAT ACCESS

Solution: Stabilize eroding shorelines by planting a vegetated buffer consisting of a combination of native plants and erosion control mulch, or install a rain garden. The roots from these plants will stabilize the shoreline, filter pollutants running off the land, and provide habitat for wildlife. Alternatively, just let the shoreline naturalize by not mowing a wide strip along the shoreline.

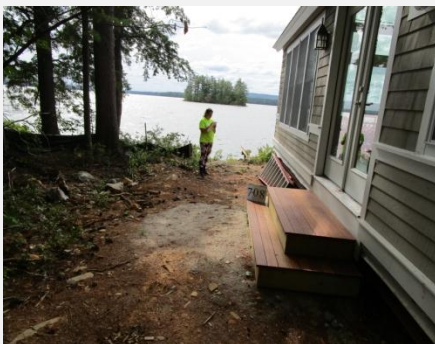
Sector 7: Site 8

Problem: ROOF RUNOFF EROSION, SURFACE EROSION, BARE SOIL

Solution: Install temporary Best Management Practices (BMPs) before construction begins to prevent delivery of sediment to the lake. These may include erosion control mulch berms, hay bales or silt fences. Permanent BMPs must be installed following construction to stabilize all bare soil areas. This includes installing a healthy buffer of vegetation along the shoreline, and vegetating or mulching all bare soil.
